EVALUATION OF GUZELYALI SETTLEMENT IN TERMS OF FIRE RESISTANCE

Prof. Dr. Füsün Erduran Nemetlu^{1,a}, - Busegül Yüksel^{2,b*}

The aim of this study is to examine the post-fire area in Güzelyalı Village, one of the regions affected by the fire that occurred in 2025 in Çanakkale province, and to make suggestions about the rehabilitation works that can be carried out. At the same time, the measures to be taken against possible fire hazards in the region for the future were discussed.

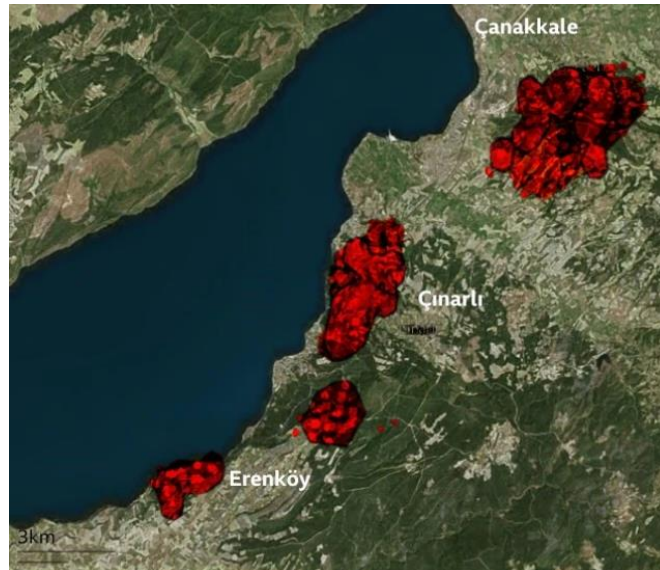
According to BBC NEWS; Interior Minister Ali Yerlikaya reported that the Çanakkale Güzelyalı fire broke out in the Çanakkale rural area on August 11, 2025 and was level 3. The map of the fire, which spread very quickly with the effect of the wind, is shown in Figure 2 [9].

Fig. 2. Image of fire taken by the Copernicus satellite on August 13, 2025 [9].

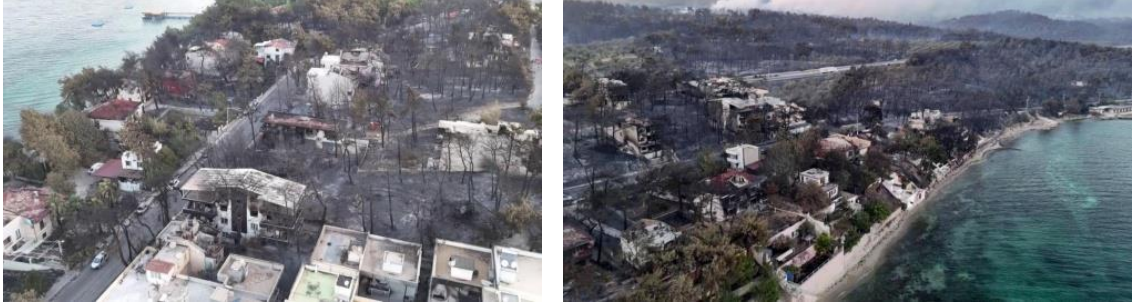
After the fire, many residences and vehicles in Güzelyalı became unusable. Fires that occurred at the same time in different regions made it impossible to intervene, and in most places, the people had to fight with their own means. Some homeowners have wet their homes with hoses and have been able to protect them from burning. However, those who did not have this opportunity suffered serious damage. The fact that the wind is hot and very fast and constantly changing direction has caused panic in the region. This situation was determined in drone images and field investigations taken after the fire (Fig. 3).

Fig. 3. Drone photos taken from Güzelyalı after the fire [10].

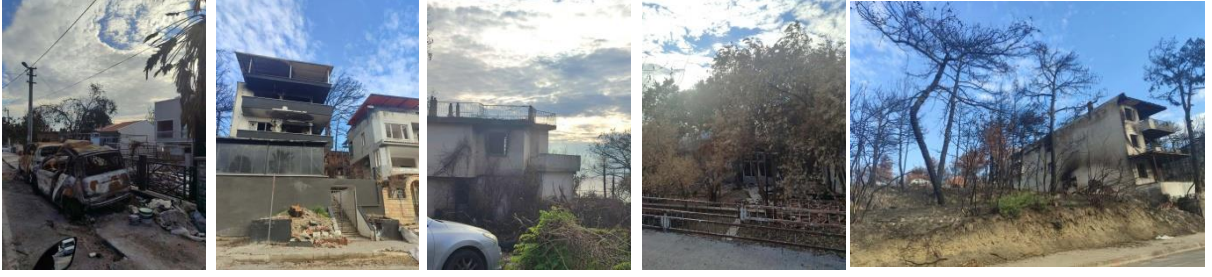
When we examine the village of Güzelyalı, which is the subject of the study, it is seen that it was established in the forest area extending from Erenköy to the coast. The lack of buffer zones between the forest and the settlements in the region is one of the most important problems. The fire, which quickly reached the settlements with the effect of the wind, caused significant damage to houses and vehicles (Fig. 6).

Fig. 6. *Güzelyalı's post-fire situation in October, 2025.*

For post-fire rehabilitation, the first measures to be taken are to create live fire stopping zones to prevent future fires, to carry out planting works that will act as wind-breaks, to convert unused roads into fire safety strips, to organize dense trees by thinning them, and to choose fire-resistant plant species [13]. Buffer zones to be created between residential areas and forests will significantly reduce the possibility of fire spreading to settlements and contribute to the formation of controllable lines for response teams.
